White Paper Report

Title of Project: Improving Environmental Conditions for Historical Collections

**American Precision Museum
Sustaining Cultural Heritage Collections project—White Paper**

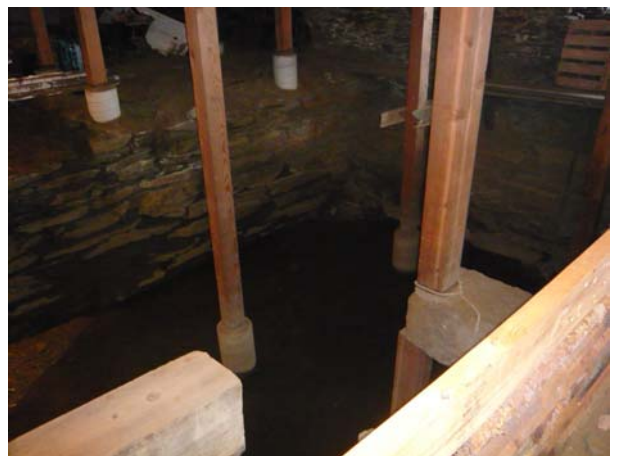
Basement Wheel Pit

The first recommended action is to prevent moisture from either entering the basement or from migrating from the basement upward through the rest of the building. In most historic houses, actions are taken to dry out of the basement so that the basement can become part of the interior building envelope. This would mean improving drainage around the building to keep water out of the basement, placing a heavy plastic sheet over the dirt floor or pouring a concrete floor that includes a vapor barrier to prevent moisture from entering through the floor, and insulating the walls, or at least applying a vapor barrier, and heating the basement or installing dehumidifiers to reduce humidity. Such actions would be very difficult to implement in the Armory basement because of the permanent water in the wheel pit and the porous nature of the laid stone foundation walls.

I propose that the real value to the basement may be as an interpretive space for visitors. I find the wheel pit fascinating just as it is with water in the bottom and the laid stone walls are beautiful. Build plank walkways, print the interpretive drawings and text on Dibond that is impervious to moisture, and light the basement "walk" dramatically and safely.

I believe a better solution would be to isolate the basement from the rest of the building by applying polyurethane foam insulation to the ceiling of the basement that is the bottom of the first floor exhibition hall's wood floor. As this floor has already been replaced and is no longer original material, there should not be a concern about applying cure-in-place closed cell high-density foam to the bottom of the floor and perhaps the sill area where the wood meets the stone. Since this type of insulation provides a good vapor barrier, it should stop moisture migrate to the upper floors, thereby reducing the moisture "pressure" on the rest of the building.

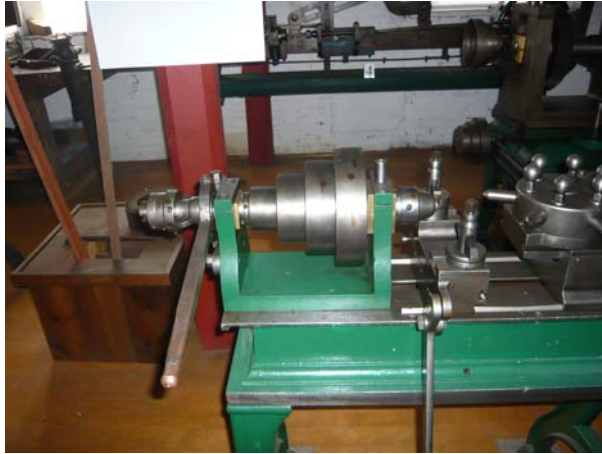
Rust on Machine

There is a very low cost and low impact approach to environmental control that should also be considered. With the exception of the paper archives, given the observed condition of the artifacts and the many years they have been stored or exhibited in the uncontrolled Armory, I suggest that it would NOT be irresponsible to leave conditions as they are now. The damp basement should be sealed off from the upper floors to prevent moisture migration upward, and a sealed, conditioned room is required to improve environmental conditions for the archives. However, the large metal industrial machinery that forms the core of the collection is in quite good condition even though it has been stored and exhibited in what would be characterized by most museum standards as adverse conditions. The preventive conservation action of using a wax/oil coating to protect the metal surfaces that you presently employ appears to be controlling rust that is the major concern for your core

(B) Preventing Condensation and Flash Rust – Large metal artifacts exhibited or stored in an unheated space can be in danger of moisture condensing on the cold metal surface when warm, moist air enters the space, usually on an early spring day. Water condensing on the surface of an iron or steel artifact can cause flash rust very quickly. There is little evidence that this has happened at the APM, but it could in the future if the weather changes rapidly and warm air infiltrates the building while the metal artifacts are still very cold. Fortunately, such condensation is relatively easy to prevent. If the surface temperature of the metal artifacts warms at a rate that is similar to the warming of the air, the dew point will not be reached on the metal surface, and condensation will not form. To facilitate the warming of the metal objects, a thin layer of insulating cold air that forms immediately adjacent to the metal surface must be dispersed. This is quite easy to do by simply using fans to move the air around the space. Fans should be turned on as soon as the outside air temperature goes above freezing and left on until the equipment warms to air temperature and does not cool down significantly again at night. This is usually a two to three week period when the fans should be operated. Simple box fans can be positioned around the space. Three or four per floor should be sufficient. Permanent ceiling mounted paddle fans also move air well and are inexpensive to purchase and simple to install. If mini-splits are used, they can simply be activated in a “fan” mode and allowed to run until the danger of warm, moist air enveloping cold metal machinery is past.

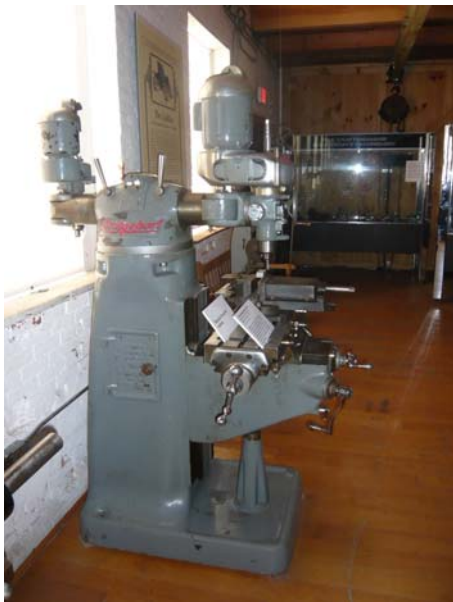
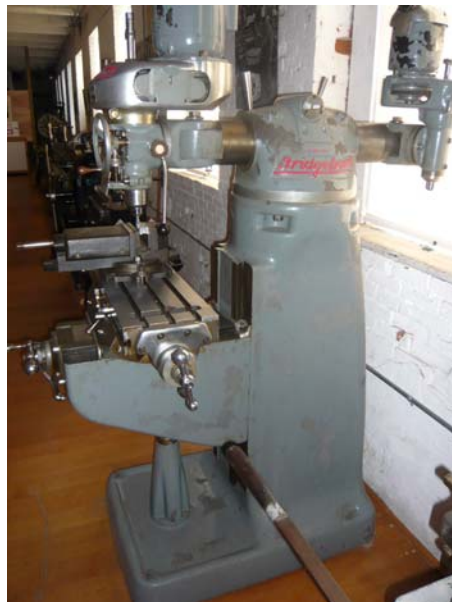
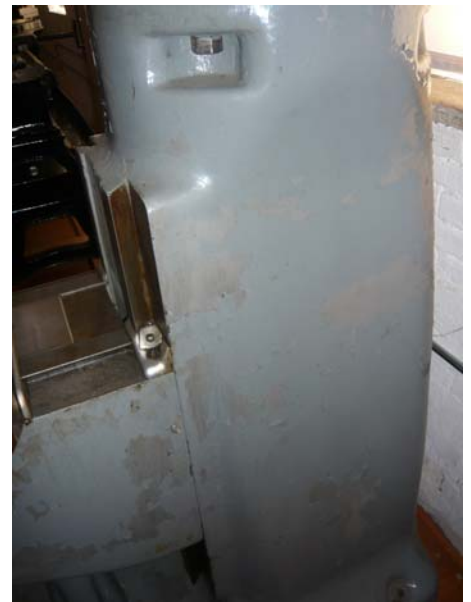
Flaking Paint, A, B and C

(A) Proofing – An important factor affecting the preservation of collection artifacts made from organic materials in most historic building museums in Vermont is the fact that they have been subjected to relative humidity levels above 70% and below 25% for extended periods of time over the past 100 years. This is actually good news, because it means that the artifacts have been “proofed” to a relatively broad RH range. Any damage caused by very dry winter conditions or very humid summer conditions has already occurred (see Chapter on “Incorrect Relative Humidity” by Stefan Michalski on the CCI website). Your collection of large metal artifacts does not really benefit from proofing because inorganic materials do not change dimensions with changes in temperature and humidity to any significant extent, and they will still continue to rust if the RH is too high. Probably the main artifact in your collection that has benefited from proofing is the large painting on canvas in the Armory lobby that must shrink as it dries in the winter and expand during the summer. Eventually these extremes may cause the paint to crack and flake from the canvas, but to date it appears to be in good condition.

One caution – conservation treatment of an artifact resets the “proofing” clock. When a damaged artifact such as the table with the crack in the top is conserved and the crack is glued together, new stresses can be set up in the wood and it may crack in a different place if again exposed to low humidity conditions. However, a good conservator should be able to treat the artifact so that it will be resilient through a relatively wide relative humidity range. Often this means making sure the original construction works, i.e. wide wood panels float freely in a frame to prevent cracking when the wood swells and shrinks in response to the changing environment.

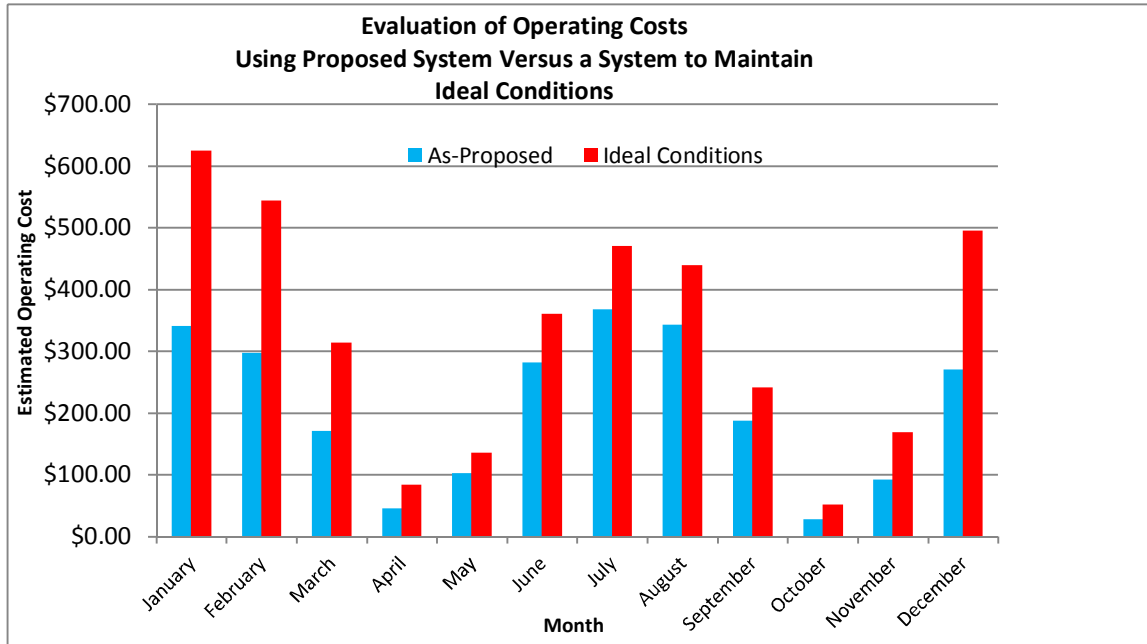
TABLE 1 - Operating Cost comparison of an ideal HVAC system versus Recommended Systems (Analysis is for one floor, other will be similar)

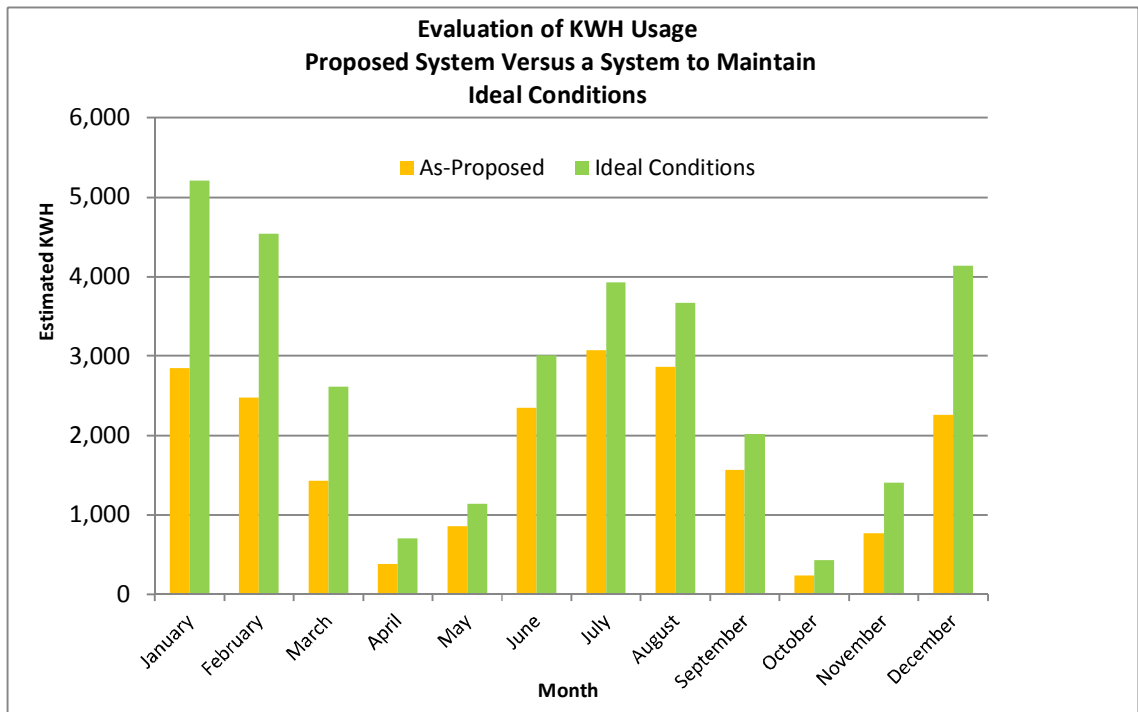
TABLE 2 – Energy Usage comparison of an ideal HVAC system versus Recommended Systems (Analysis is for one floor, others will be similar)
